**Missouri River Flood 2011  
Vulnerabilities Assessment Report  
Volume II-Technical Report**

**Northwestern Division  
US Army Corps of Engineers**

**October 2012**

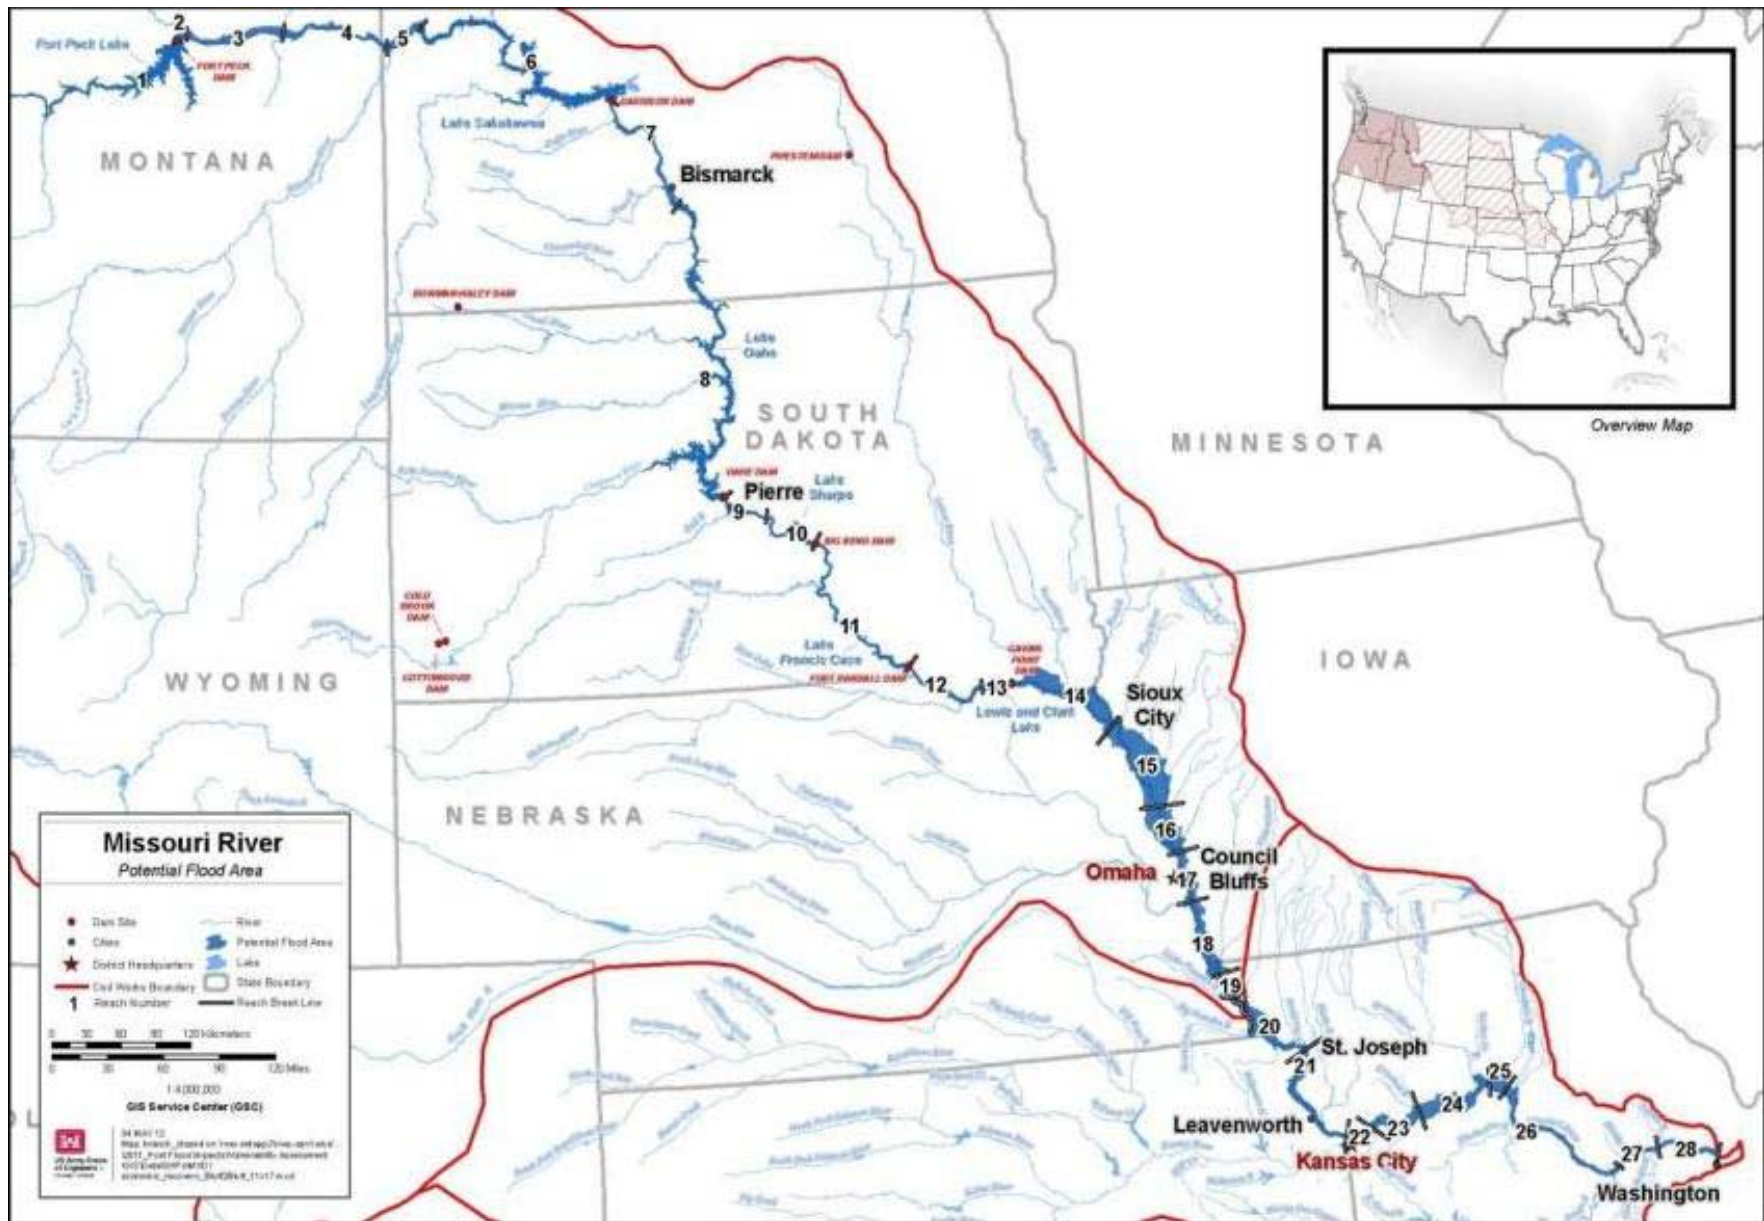
Figure 3. Potential Flood Area

The floodplain width is defined as the bluff line on either side of the river. It varies widely in width from just over a mile at its narrowest to over 17 miles at its widest point, with an average of about three miles for the entire reach. Table 1 lists all 28 reaches and Figure 3 displays the entire Missouri River basin and also identifies the potential flood area as extending from bluff to bluff. The stretch of the Missouri River for this assessment extends from Fort Peck Lake headwaters (river mile 1931) to near Washington, Missouri (river mile 66). Due to the large geographic extent of the area, the river has been divided into 28 reaches. These reaches are also based on those delineated in the *Missouri River: Re-Evaluation of Main Stem Flood Control Benefits Report* (USACE, 1955). Since major tributaries have influence on mainstem flooding, many reaches have boundaries beginning and ending at major tributaries. Other reaches are based on major urban centers. The reservoirs are generally treated as their own reaches. These reaches, though altered slightly and interpreted differently over time, are still used today for mainstem stage-damage curves by Northwestern Division's Omaha District (NWO) and Kansas City District (NWK).

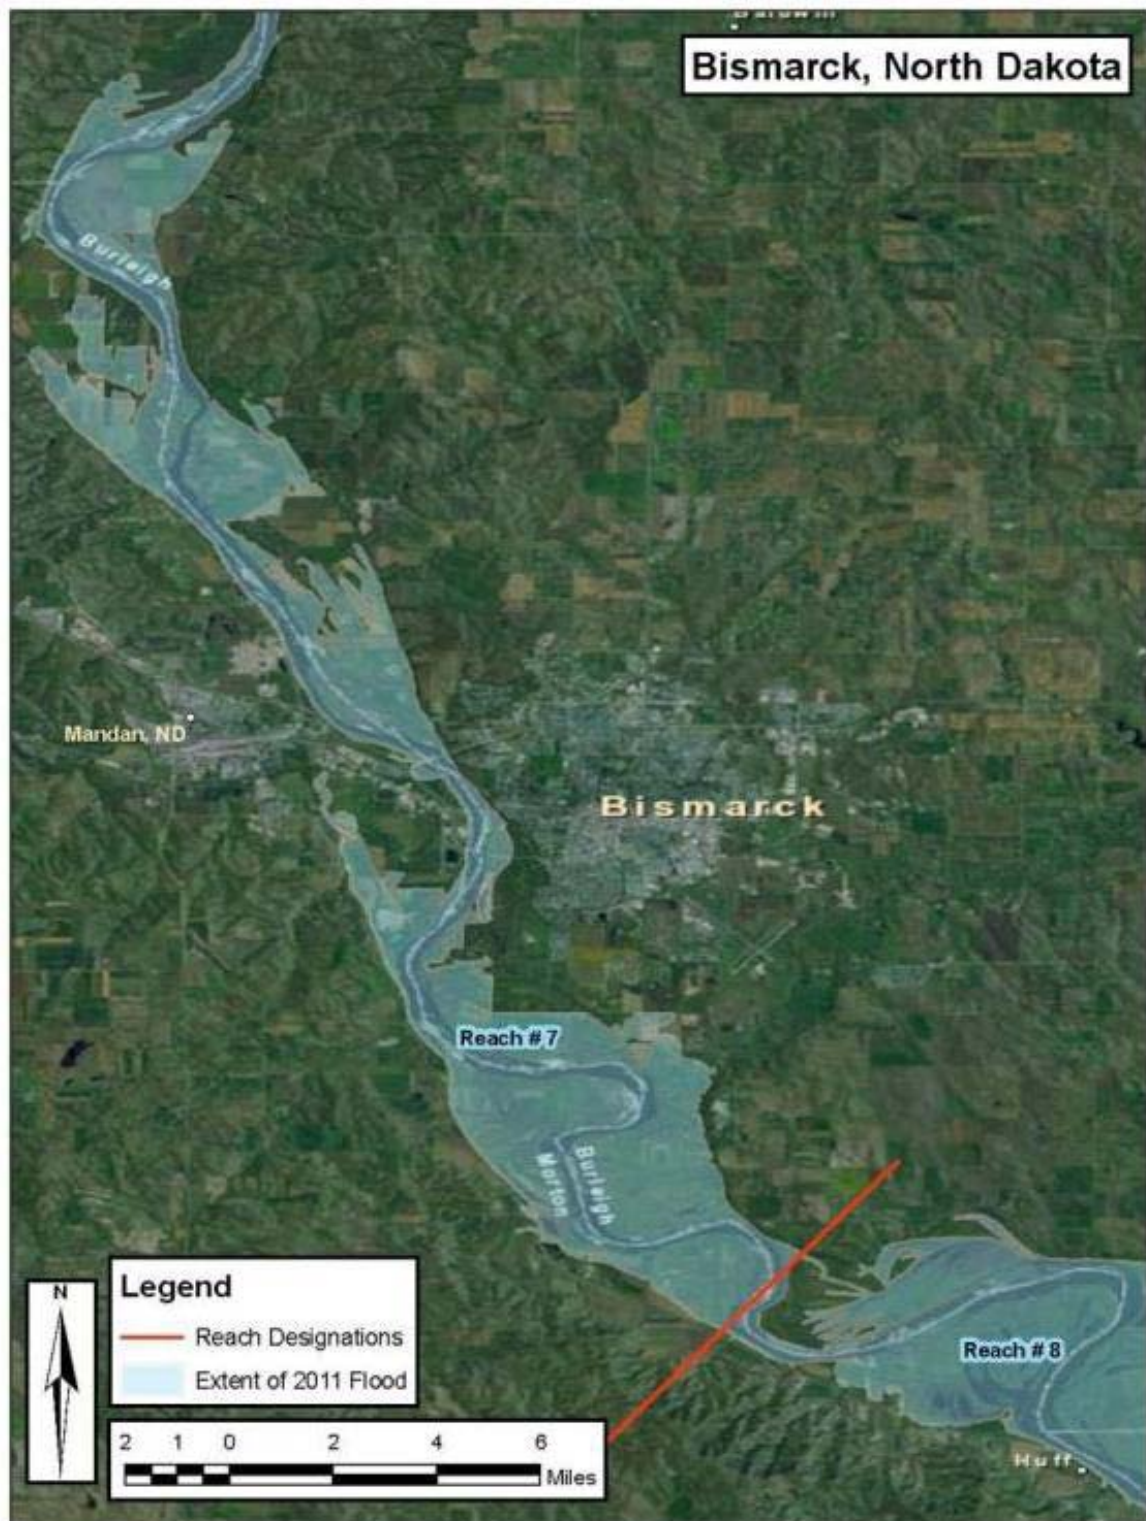
### Figure 5. Bismarck, North Dakota Reach

The Bismarck Reach (Reach 7) lies between Garrison Dam and Lake Oahe and contains the cities of Bismarck, North Dakota and Mandan, North Dakota. This reach has a large population and value of structures and contents located within the 2011 flood boundary. During the 2011 flood event, Bismarck and Mandan required Corps assistance with flood fighting efforts. This included constructing miles of temporary earthen levees and sandbagging to protect critical infrastructure (water treatment facilities on both sides of the river), an elementary school, and many residential areas. According to the 2011 After Action Report (AAR), an estimated \$10 million was spent on flood fighting efforts. Figure 5 shows the extent of the 2011 flooding for the Bismarck Reach.

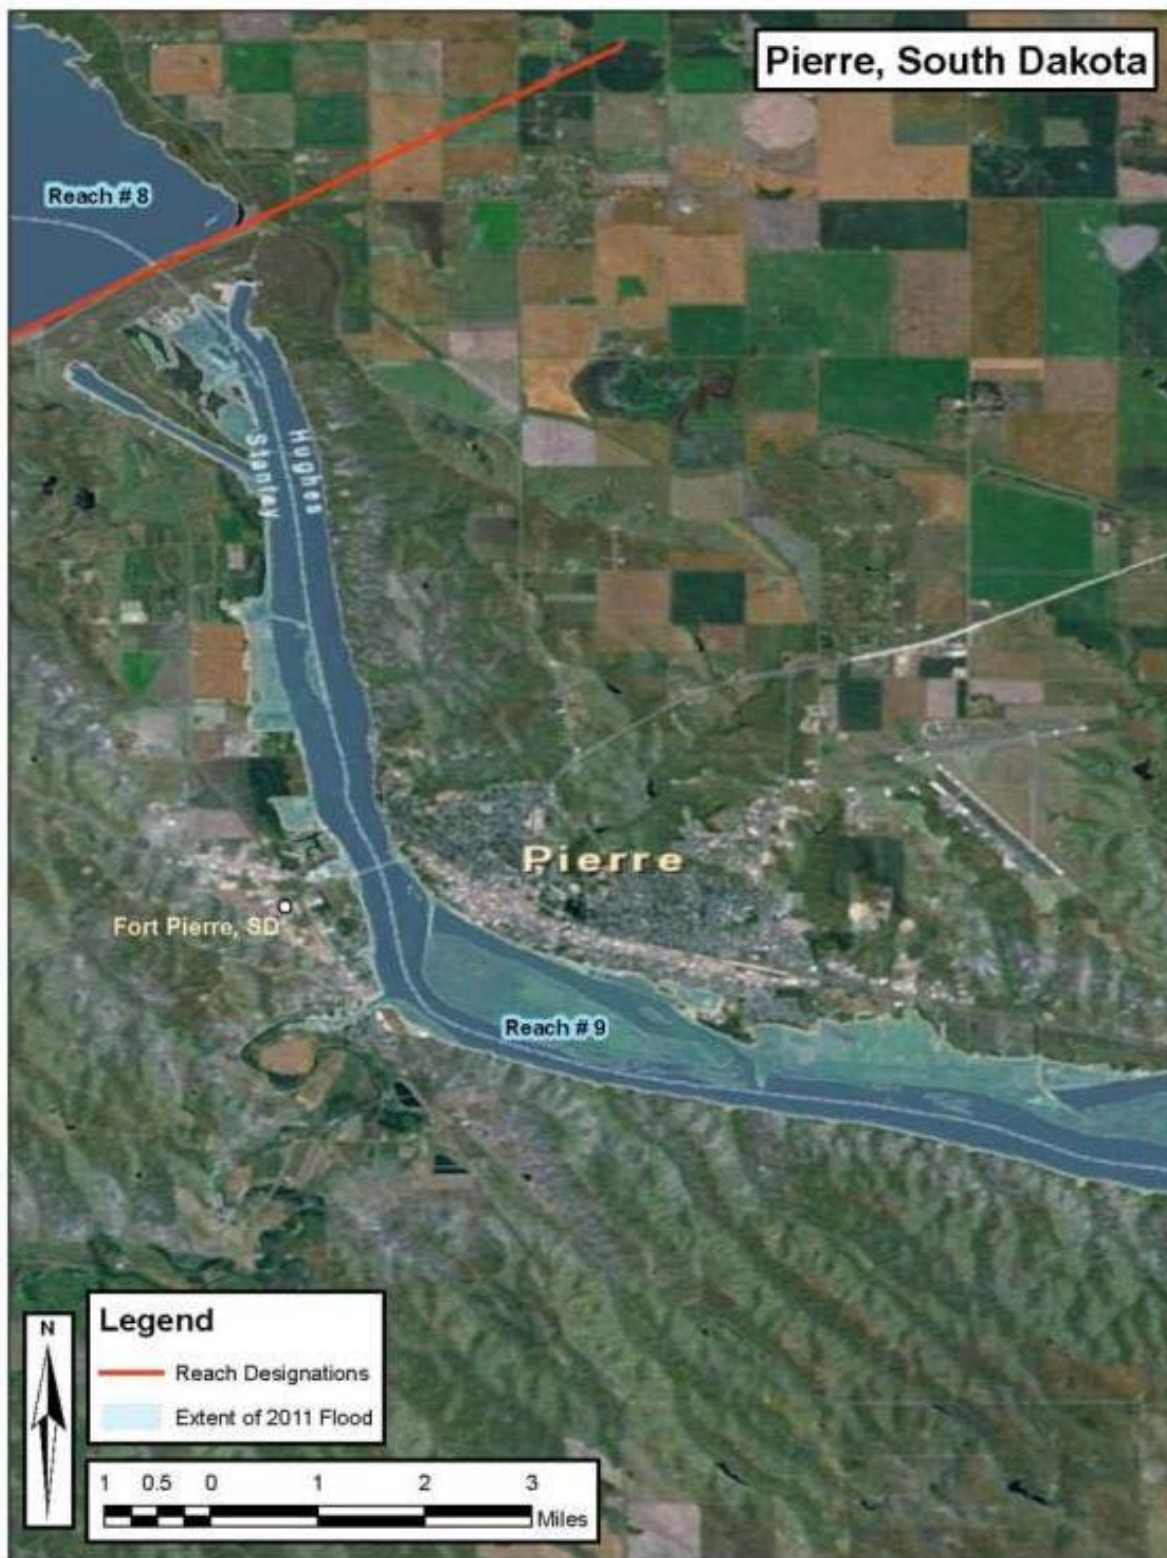
Figure 6. Pierre, South Dakota Reach

The Pierre reach (reach 9), which lies in between Oahe Dam and Lake Sharpe, contains the cities of Pierre, South Dakota and Fort Pierre, South Dakota. Major impacts to the Pierre and Fort Pierre area were avoided through substantial emergency flood fighting efforts, many of which were for protection of water and sewage facilities. According to local officials, the consequences of losing the water and sewage infrastructure could have led to transporting water into the cities by truck, which would have been very costly. According to the 2011 AAR, around four miles of clay levee were constructed on both sides of the river, with estimated costs near \$10 million. Figure 6 shows the extent of the 2011 flooding for the Pierre reach.

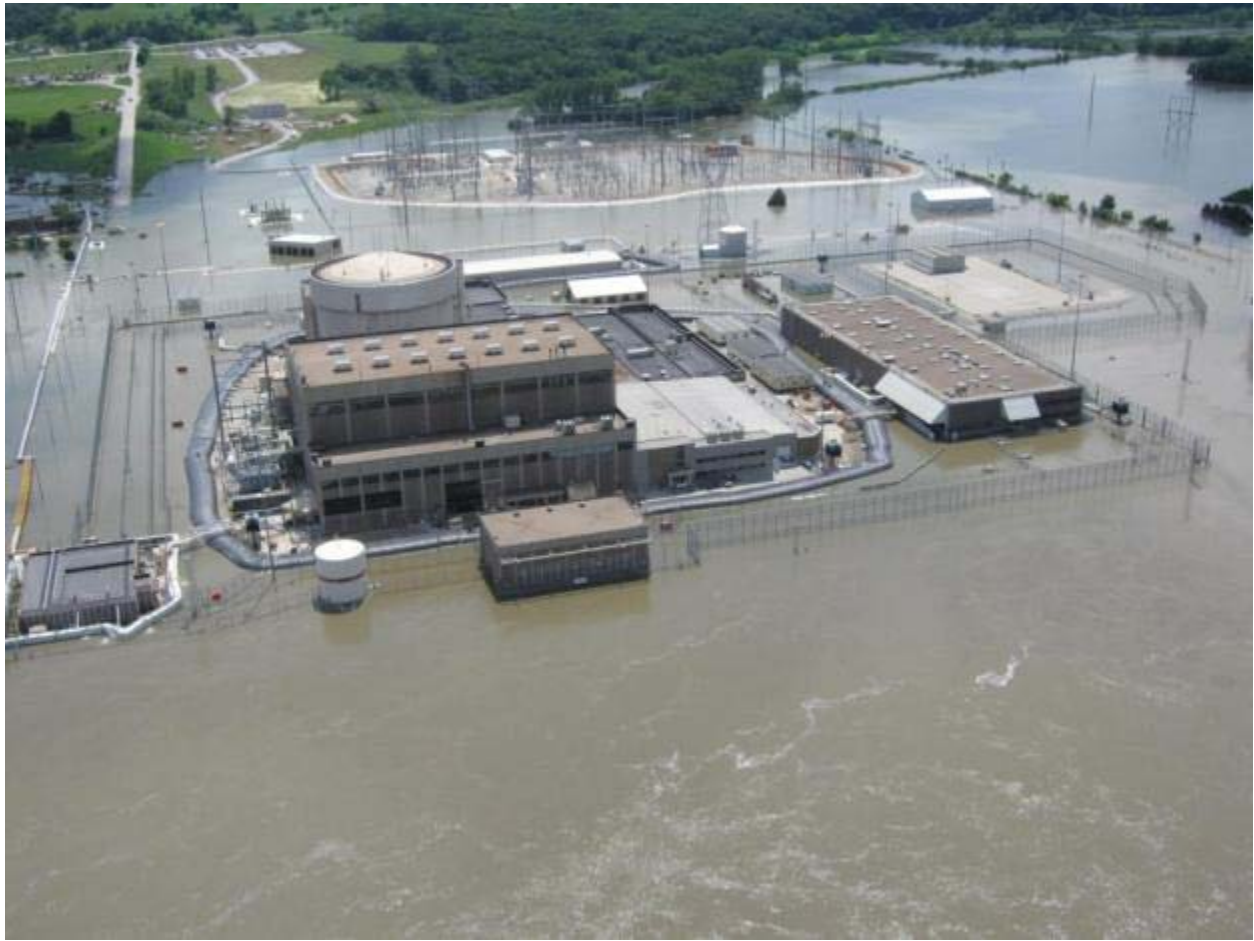
**Figure 9. Fort Calhoun Nuclear Station (June 25, 2011)**

Of special significance, the Fort Calhoun Nuclear Generating Station, owned and operated by OPPD, experienced substantial impacts related to the 2011 flooding. The Fort Calhoun Station is located adjacent to the Missouri River between Fort Calhoun and Blair, Nebraska (reach 16) and was surrounded by flood waters from the 2011 flooding (Figure 9). While the nuclear reactor at the plant had been in shut down mode for scheduled refueling, the flooding resulted in the reactor remaining in shut down mode. According to OPPD, the Nuclear Regulatory Commission has placed the Fort Calhoun Station in an extended shutdown due to performance issues related to the flood and other regulatory issues. It was estimated that \$36.4 million was spent on flood-fighting and protective measures related to Fort Calhoun Station.

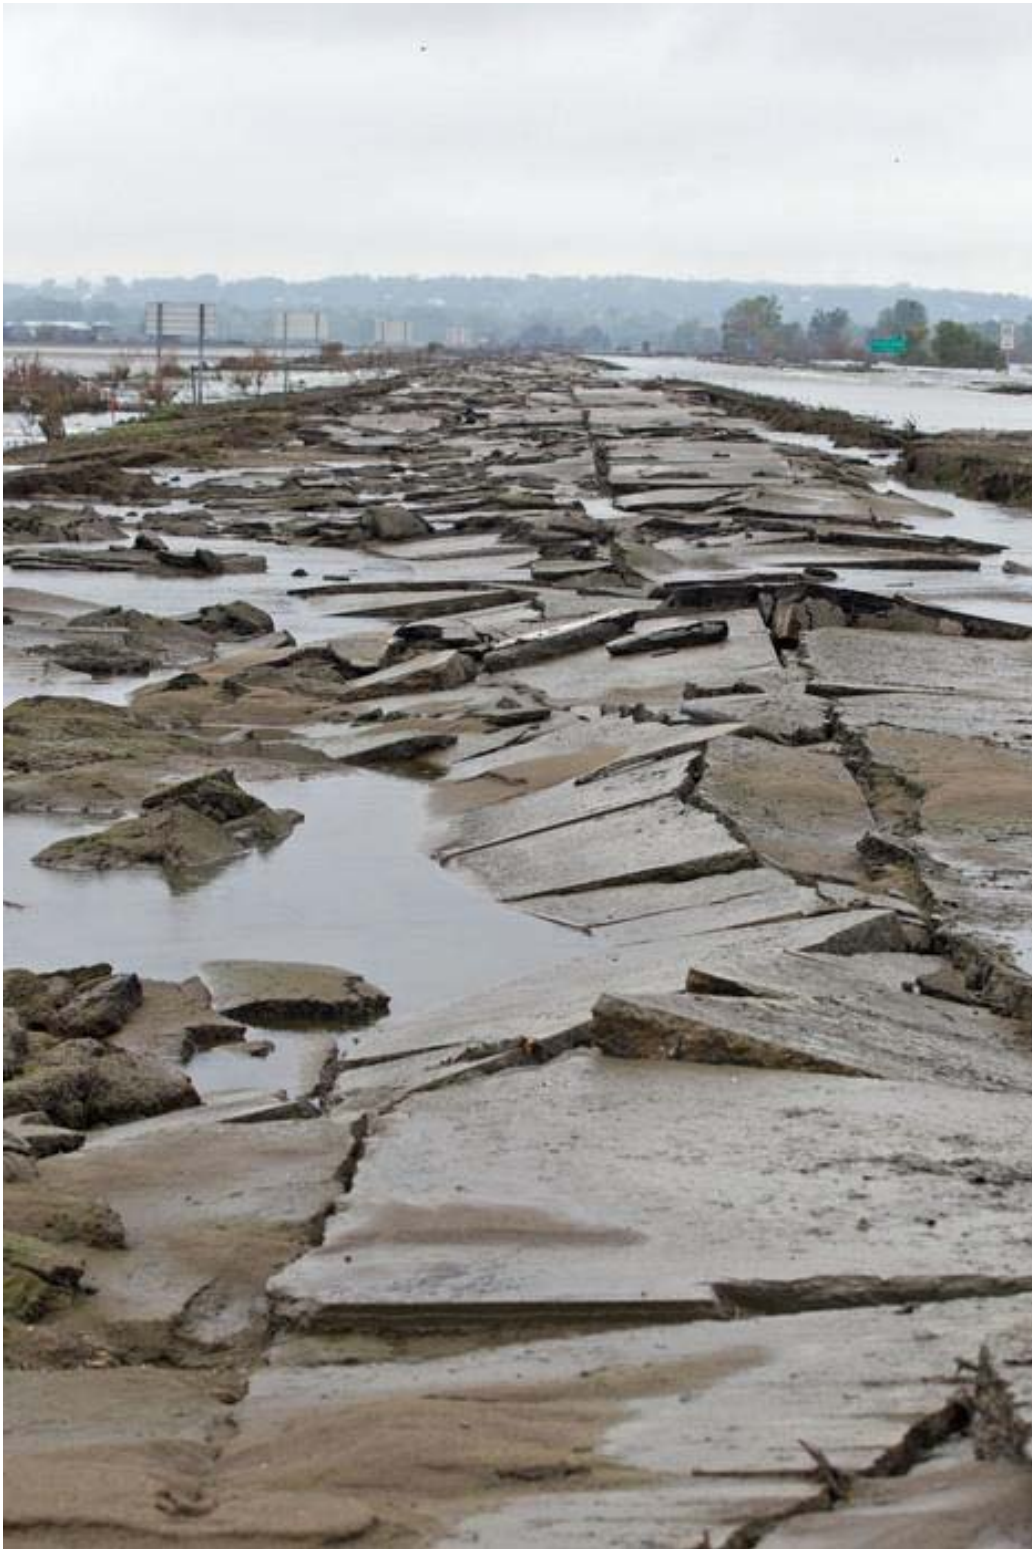
**Figure 10. Omaha World Herald Photo: The flood-damaged eastbound lane of Interstate I-680, looking west toward the Mormon Bridge from the overpass over I-29. Receding water from the flooded Missouri River revealed flood damage north of Council Bluffs.**

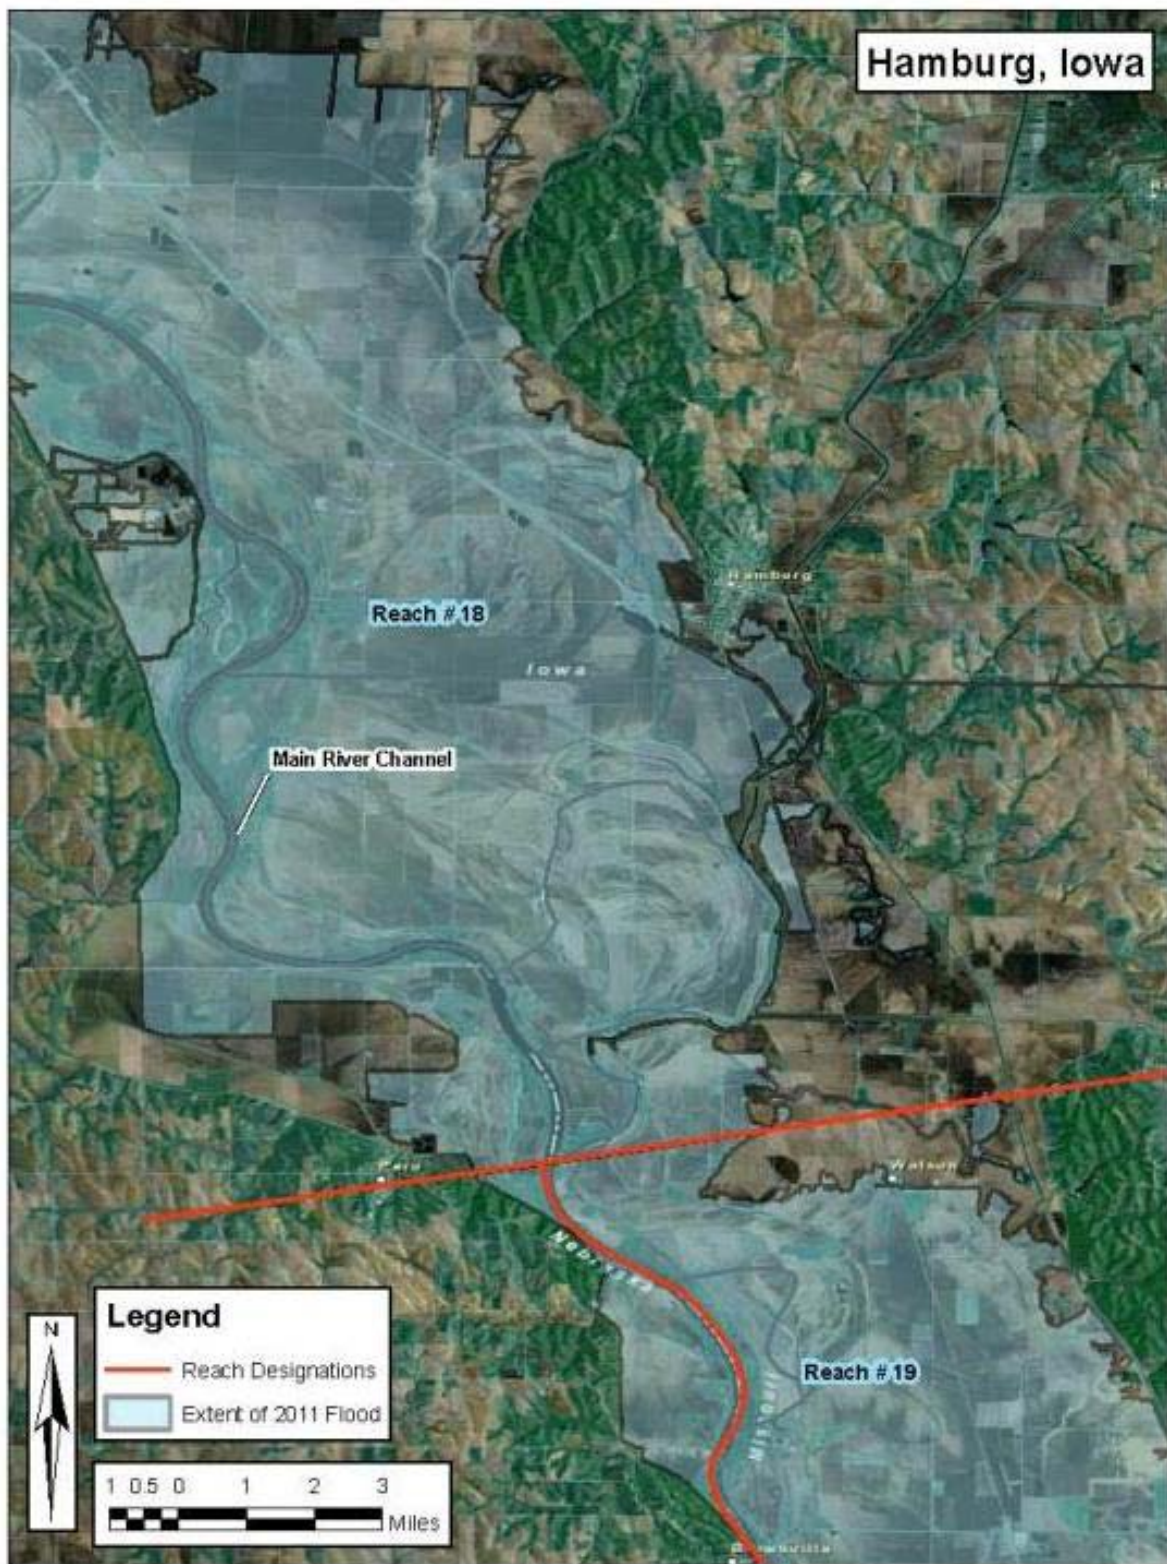
Figure 12. Hamburg, Iowa in Reach 18

Figure 12 shows the extent of the 2011 flooding for the area around Hamburg, IA south of Omaha/Council Bluffs, and within the Nebraska City reach (reach 18), which is an especially vulnerable reach. The Missouri River can be seen on the left side of the picture and Interstate I-29 can clearly be seen within the flooded area following five levee breaches in L-575 and L-550. Note that at the widest part, the flooded area approaches 17 miles wide in what is an important regional north-south corridor and east-west crossing for interstate and railroad travel and commerce, as well as being some of the most productive agricultural areas in the nation. Cooper Nuclear Power Station is just a few miles south (downstream, on the Nebraska side) of the area shown.

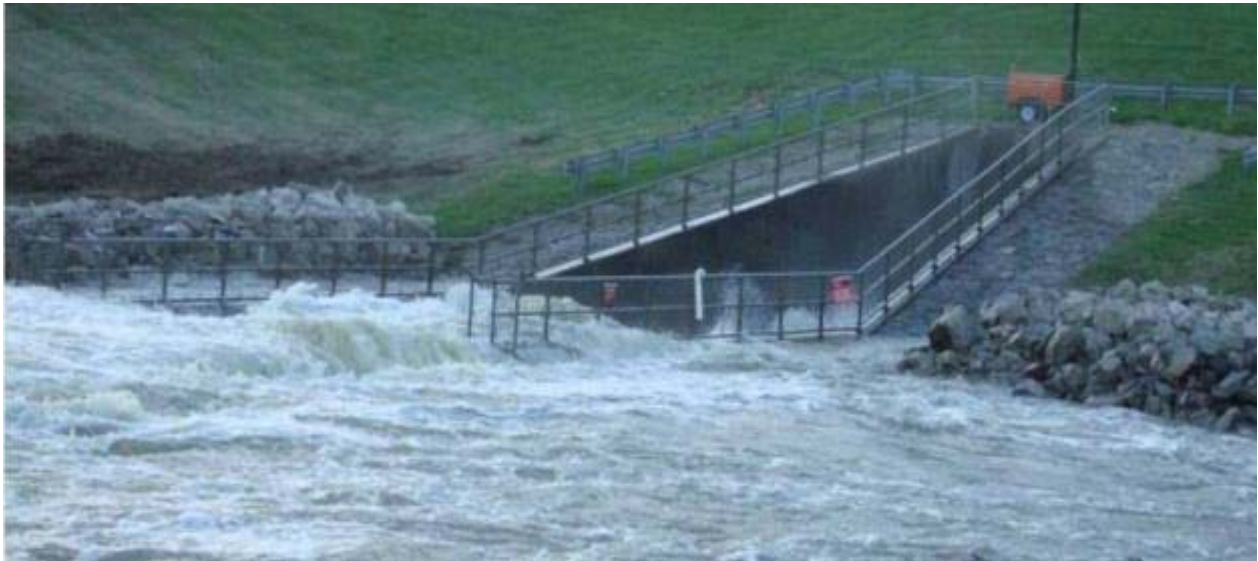
Discharges have also been limited by the stilling basin capacity, which overtops at about 1,800 cfs (about 1/3 of the design discharge). Modifications during the 2010 high pool have mostly alleviated concerns from stilling basin overtopping. Flood supplemental funding was obtained during the 2010 high pool that was used for dam safety modifications in addition to repairing park damages. The most significant modification included placement of riprap scour protection in the outlet channel adjacent to the stilling basin.

**Figure 14. Rathbun Stilling Basin Overtopping at 3,000 cfs**

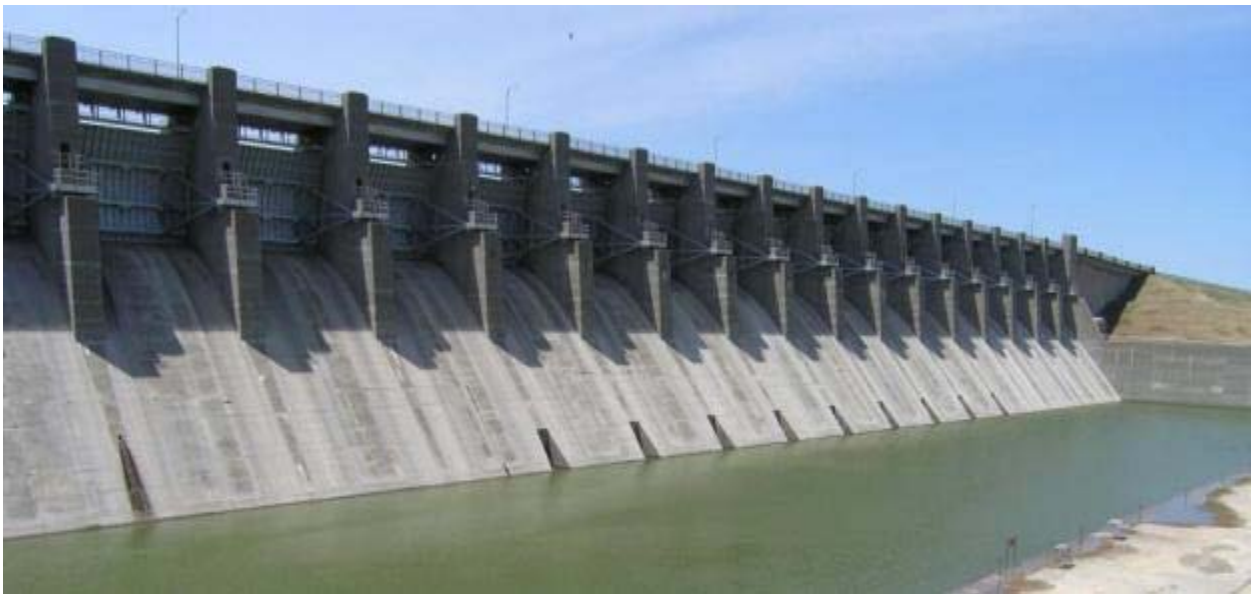
**Figure 15. Harlan County Spillway and Stilling Basin**

Harlan County has a pool restriction at elevation 1,962 feet msl (approximately mid-height on the Tainter gates). The pool restriction is a perpetual deviation request that will be renewed until the gates are rehabilitated. The deviation request implemented in 2003 was labeled as an Interim Operating Plan (IOP). The Interim Risk Reduction Measures (IRRM) plan recognized the IOP as an IRRM already implemented. The pool elevation in the IOP was selected to prevent Tainter gate buckling due to overstress resulting from trunnion friction. The IOP modifies the flood control operation of the Tainter gates by reducing the maximum design load of 30.0 feet of water to only 17.5 feet before flood waters are released. This premature release is intended to reduce the likelihood of gate failure for dam safety purposes, but it reduces the project's flood control benefits.

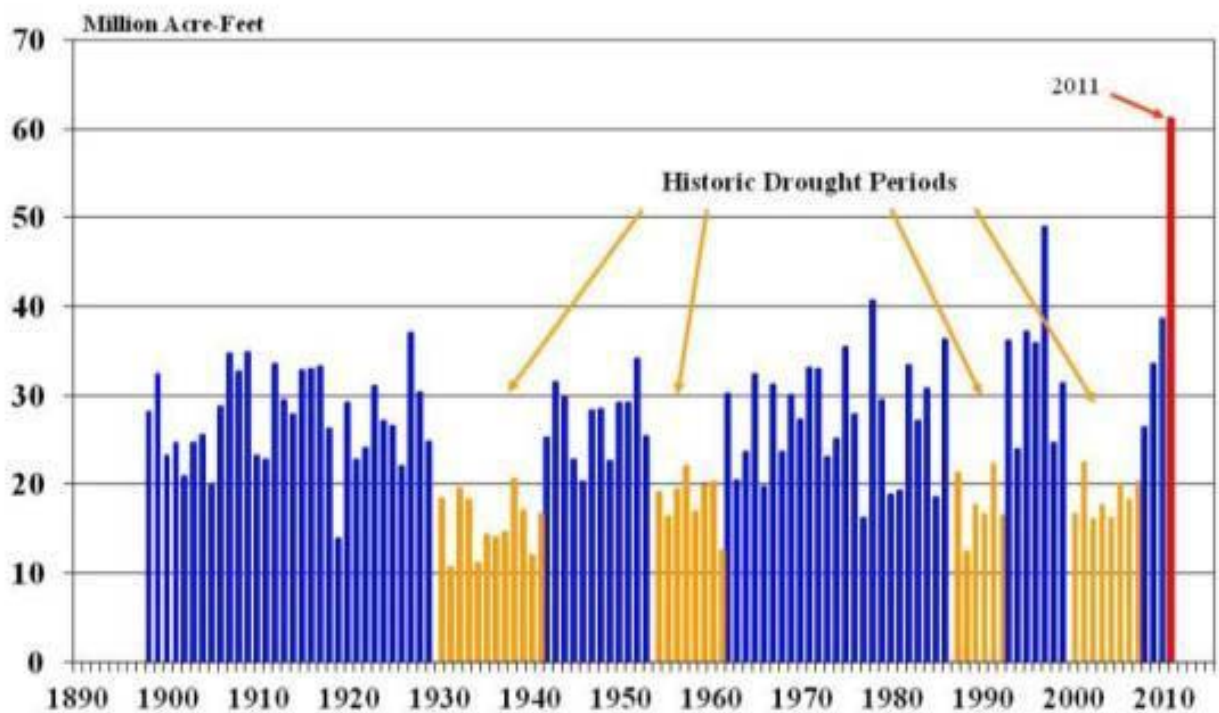
Figure 16. Missouri River Basin - Annual Runoff above Sioux City, Iowa

On average, 23 percent of the annual runoff above Sioux City, Iowa is received in March and April as a result of plains snowmelt augmented by early spring rains. About 50 percent of the annual runoff comes May, June, and July and about 25 percent in March and April as a result of the melt of the mountain snowpack augmented by late spring and summer rains. Runoff varies widely from year to year but averages 24.8 MAF annually above Sioux City. Records dating back to 1898 indicate runoff has varied from a high of 61.0 MAF in 2011 to a low of 10.7 MAF in 1931 as shown in Figure 16. Prior to 2011, the previous record runoff was 49.0 MAF in 1997. The average annual runoff between Sioux City and Hermann, Missouri, the last major gaging station on the Missouri River, is 44.0 MAF.

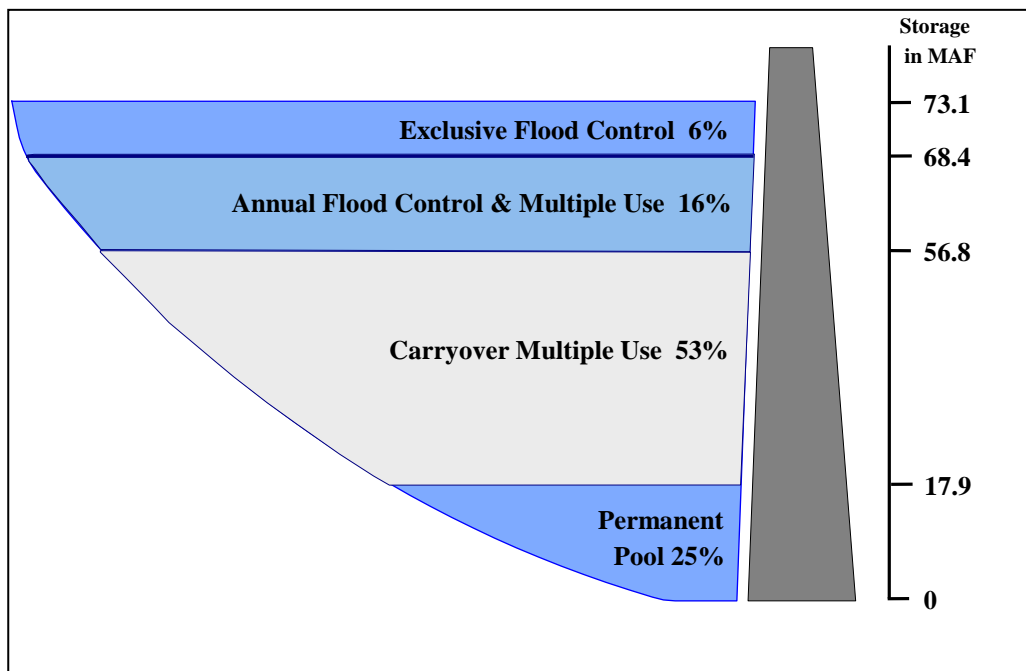
Figure 17. System Storage Zones

The combined storage capacity of all six mainstem reservoirs is 73.1 MAF, about three times the annual runoff in the basin above Sioux City, Iowa. This high ratio of storage capacity to runoff lends an unusual degree of flexibility to the regulation of the multipurpose reservoir system. The storage capacity of the system and each reservoir is divided into four unique storage zones for regulation purposes, as shown in Figure 17. The bottom 25 percent of the total storage capacity comprises the permanent pool designed for sediment storage, minimum fisheries, and minimum hydropower heads. The largest zone, comprising 53 percent of the total storage capacity, is the carryover multiple use zone which is designed to serve all project purposes, though at reduced levels, through a severe drought like that of the 1930's. The annual flood control and multiple use zone, occupying 16 percent of the total storage capacity, is the preferred operating zone of the system. Ideally, the system storage is at the base of this zone at the start of the spring runoff season. Spring and summer runoff is captured in this zone reducing flood risk between and below the mainstem dams and then the stored water is metered out through the remainder of the year to serve the other project purposes, returning the reservoirs to the base of this zone by the start of the next runoff season. The top 6 percent of the system storage capacity is the exclusive flood control zone. This zone is used only during extreme floods, and evacuation is initiated as soon as downstream conditions permit.

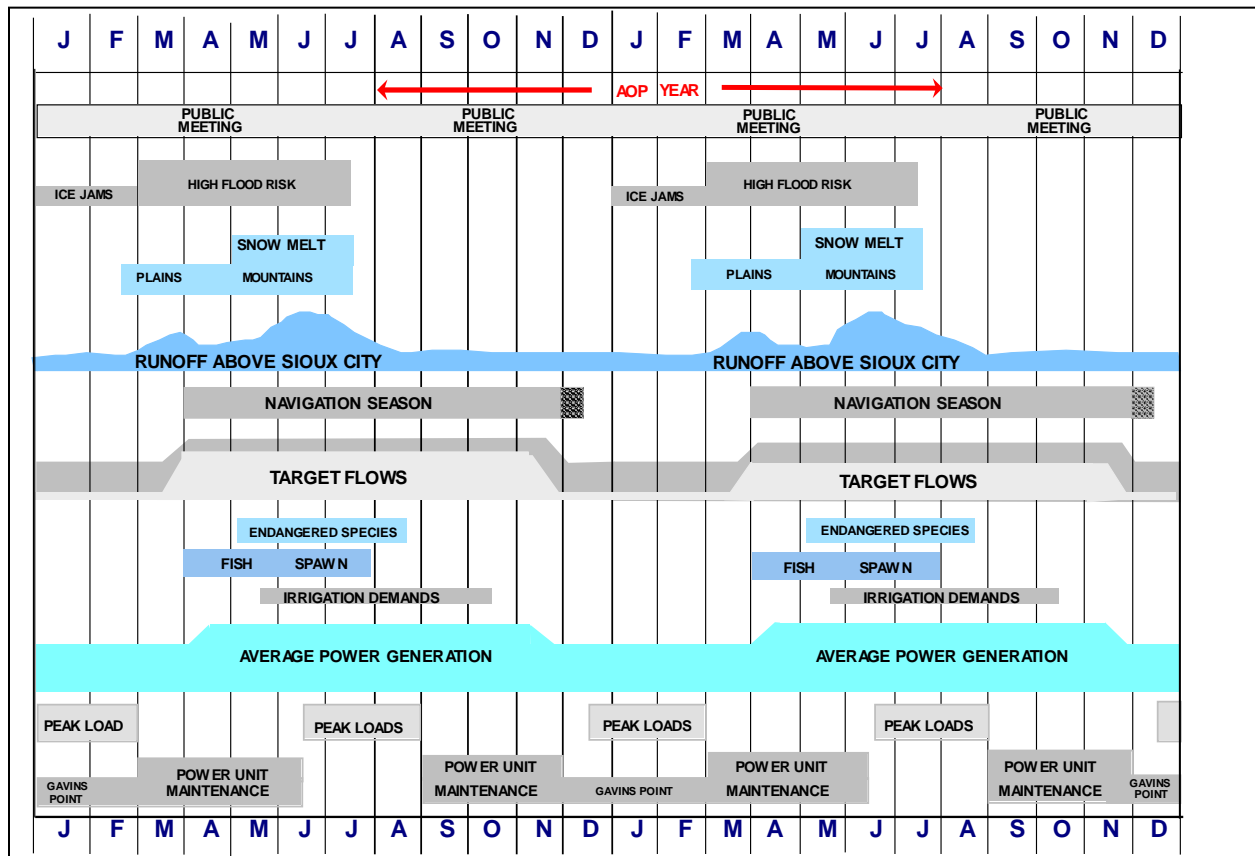
Figure 18. Water Control Calendar of Events

Regulation of the reservoir system is in many ways a repetitive annual cycle. The Water Control Calendar of Events, shown on Figure 18, displays the time sequence of many of the cyclic events driving system regulation. The water control plan is designed to achieve the multipurpose objectives of the system given these cyclical events.

The two primary high-risk flood seasons shown in Figure 18 are the plains snowmelt season from late February through April, and the mountain snowmelt period of May through July. Runoff during both of these periods may be augmented by rainfall; this is particularly true in the lower basin where flooding is often the result of heavy rain below the system. The winter ice-jam flood period extends from mid-December through February.

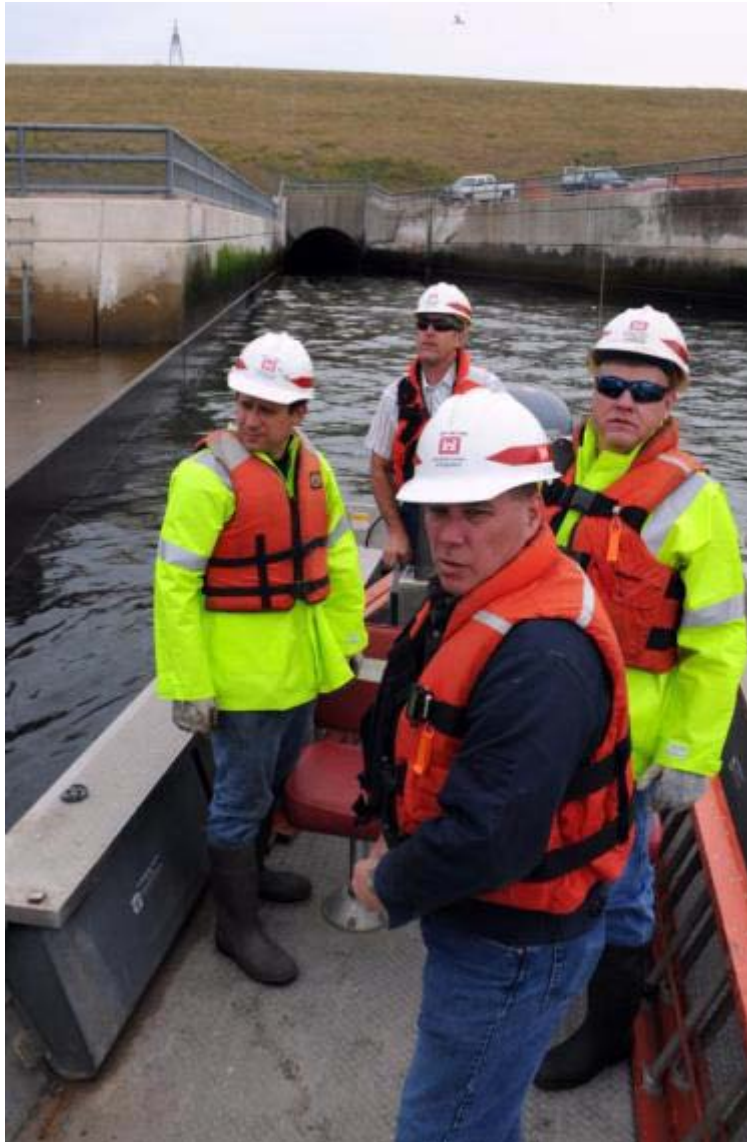
**Figure 20. Oahe personnel prepare to enter one of the Oahe Dam stilling basin outlet tunnels August 29, 2011. They drove boats one half mile into the tunnels to visually inspect tunnel walls for cracks, spalls or distress in the concrete.**

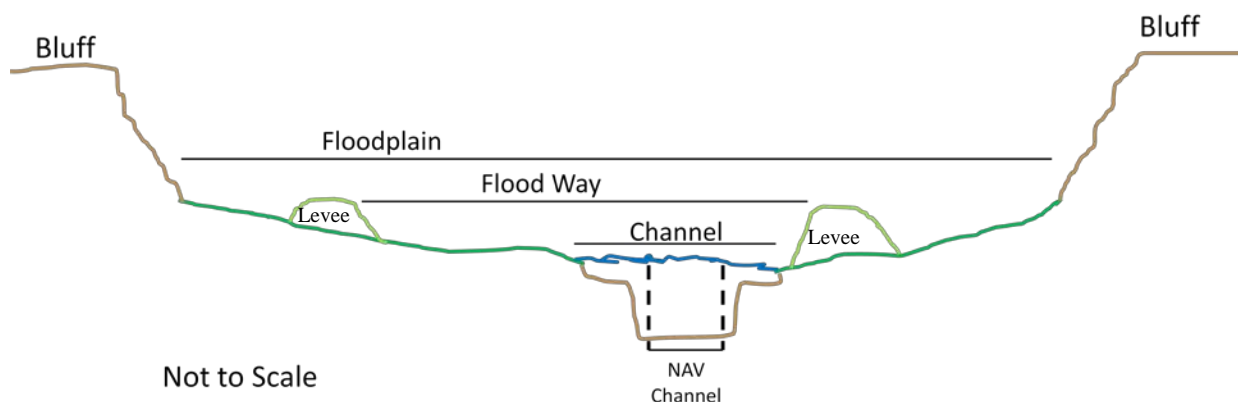
**Figure 21. Components of the river corridor**

The Missouri River corridor and conveyance system is a complex, multipurpose, multicomponent system which is partly operated and maintained by the Corps and partly operated and maintained by non-federal entities. Key components with regard to flood risk management include streambank protection structures and bank stabilization structures from Fort Peck to the mouth and an extensive system of levees constructed from Omaha, Nebraska to the mouth. Referencing Figure 21 below, the streambank protection structures and the bank stabilization structures work to prevent bank erosion and keep the channel from meandering. The levees confine the flow of the river to the floodway, preventing flooding of the adjoining land and nearby structures, and make the channel more reliable for navigation. As such there is interdependence between components and the overall performance of the infrastructure is critical for river corridor and conveyance reliability. This chapter is broken into the following sections; a description and discussion of the Bank Stabilization and Navigation Projects (section 4.1) and then a follow on discussion and description of the levee system along the river (section 4.2)

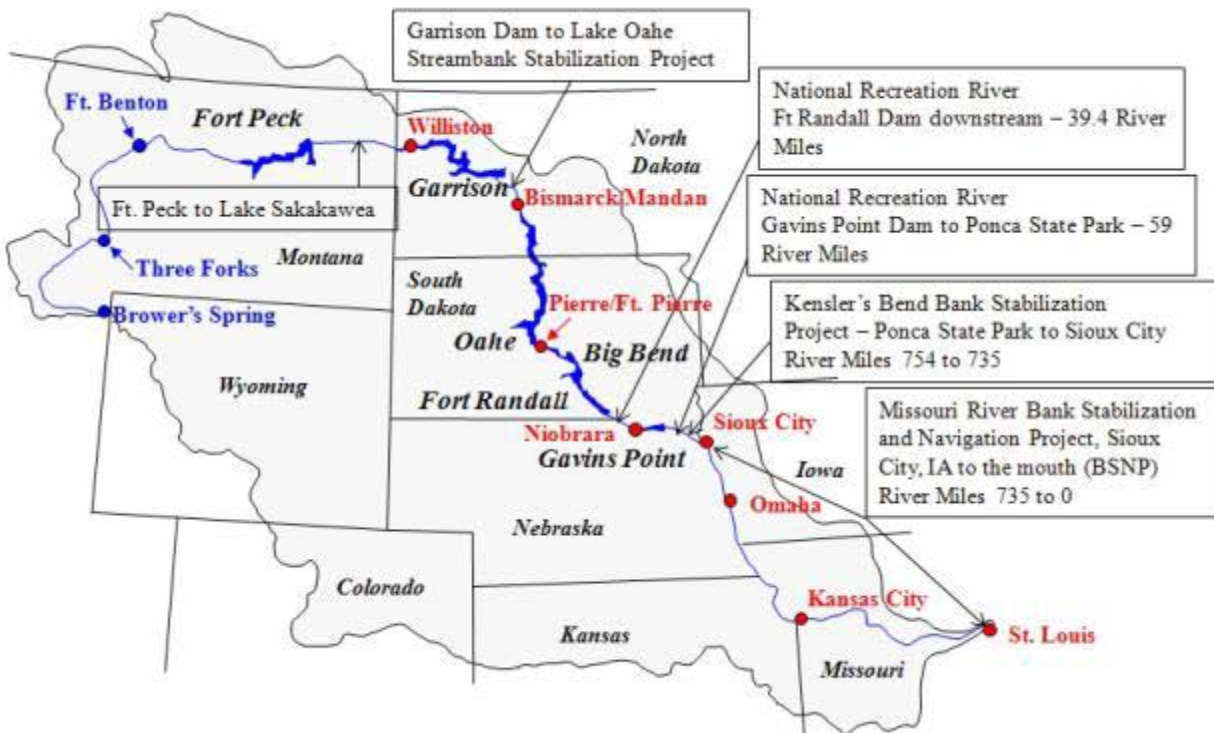
**Figure 22. Channel Performance Open River Reach Locations from Ft. Peck to the Mouth**

The Channel Performance river reaches are located between the dams and the headwaters of the reservoirs to Lewis and Clark Lake of Gavins Point Dam, and the channel sections below Gavins Point Dam to the mouth, as shown on Figure 22. The open river reaches from the Ft. Peck Dam to Ponca State Park, Nebraska include several streambank protection authorities. Downstream of Ponca State Park is the

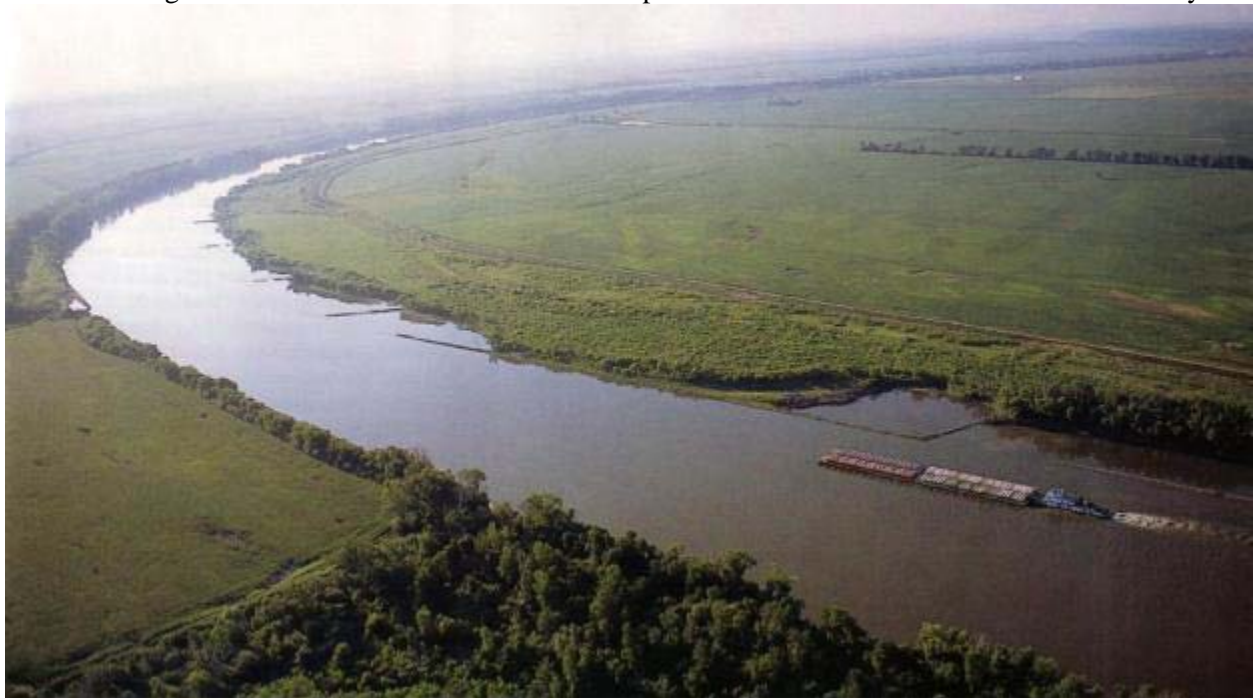
**Figure 24. BSNP Channel with Private Levee System along Right Bank near Indian Cave State Park, Nebraska River Mile 517 Prior to 2011 flood.**

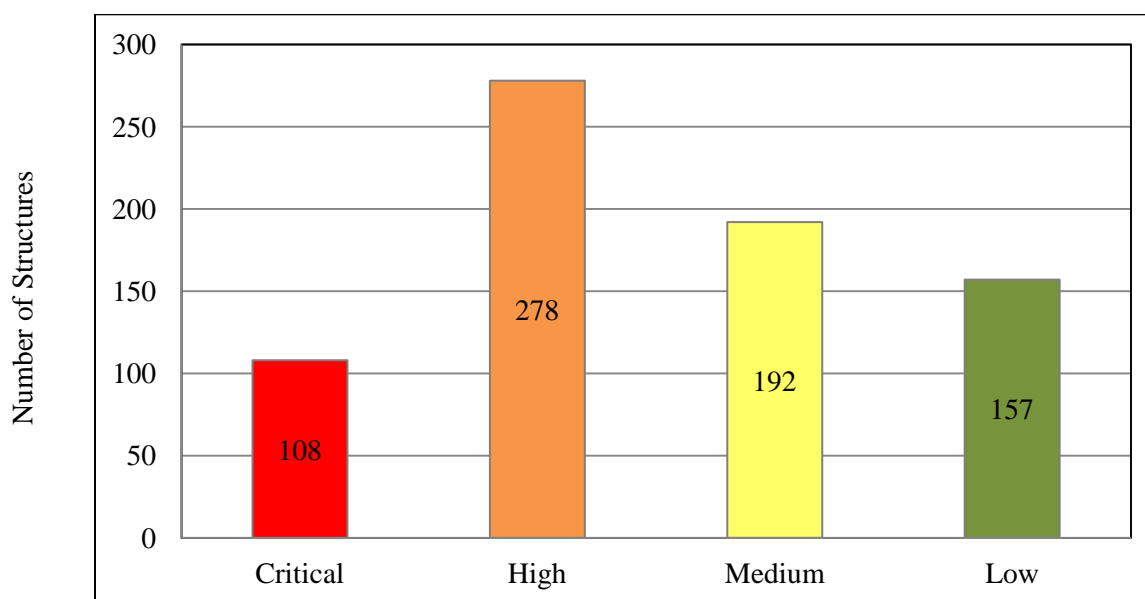
**Figure 25. Number of Structures by Priority Level**

The number of damaged structures and rock repair quantities needed were determined using the best available data. This information is summarized in Figure 25 and Table 13.

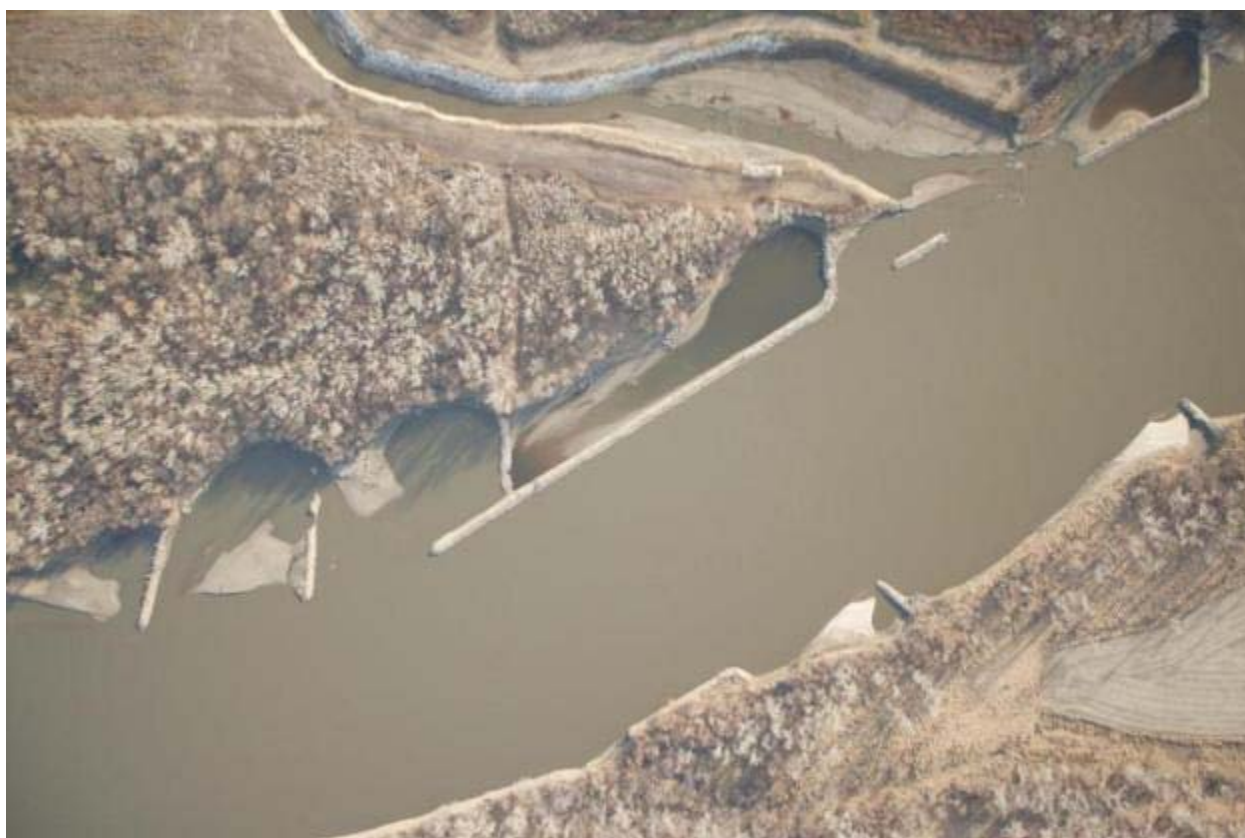
**Figure 26. Upper Kansas Bend SWH Chute Inlet at River Miler 546 - Pre Flood 2005.  
Downstream Flow to Left**

NWO and NWK have constructed a number of SWH projects under the MRRP authority. Each district performed early reconnaissance efforts to quickly provide an overview of current conditions. On-going and future study efforts will be used to provide additional information and recommendations. The following figures show some of the typical SWH chute control structure damage. Figure 25 shows a 2005 pre-flood image of Upper Kansas Bend SWH chute inlet and Figure 26 shows the chute inlet with flood damage. SWH assessments discussions that follow will be by district.
